## The tomb at Dolno Lukovo – architecture and decoration

**Georgi Nekhrizov <sup>a</sup>**

The tomb near the village of Dolno Lukovo was found during rescue excavations in 1992, and it is remarkable for its architecture and, especially, its decoration. It consists of a burial chamber almost quadrangular in plan, with south facing entrance, an antechamber opened to the south and a dromos whose length is not defined. The chamber and the antechamber are built on a crepidoma made from nicely cut marble slabs of various sizes. The chamber has a pitched roof, consisting of four pairs of solid lime blocks. The antechamber is narrower and lower than the chamber. Each of the walls is made from two lime blocks with a rusticated frontal face. The roof is similar to the one of the chamber but it consists of two pairs of blocks. The dromos is made from local crushed stones bound by clay. Its walls are leaning outwards probably to support the soil cover of the mound. The interior of the tomb near the village of Dolno Lukovo was covered with mortar plaster. Small pieces of it have survived and have been found *in situ*.

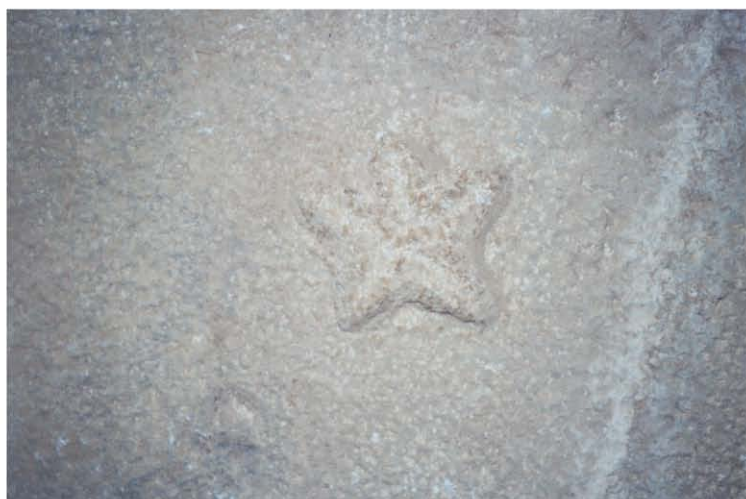
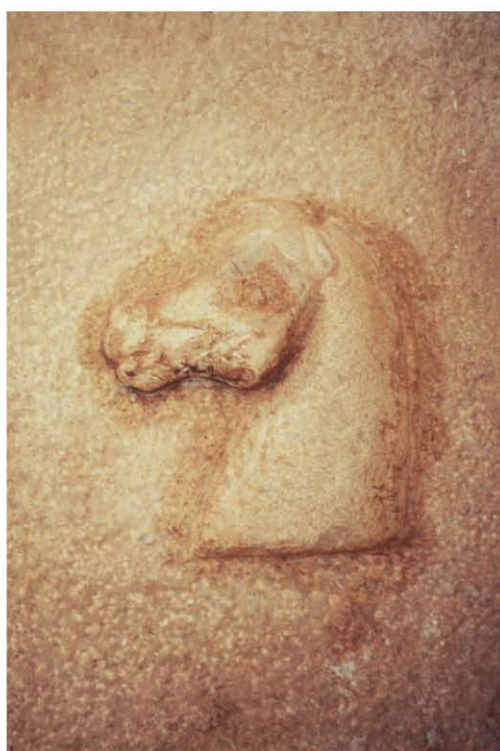
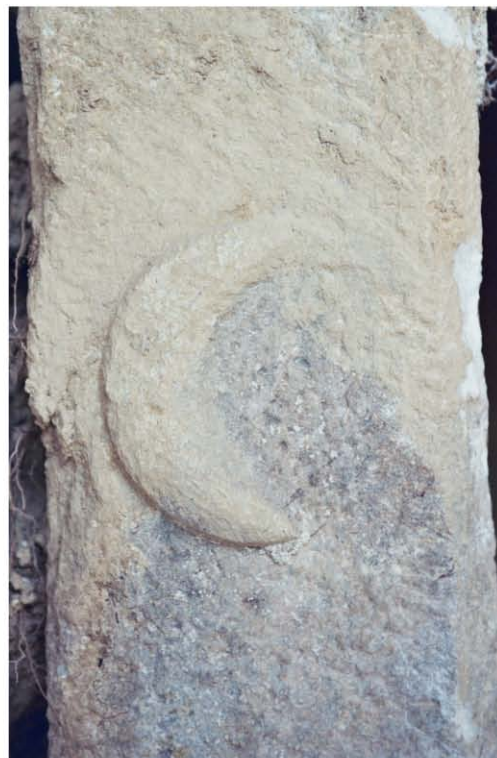
*Fig. 6. Relief figures on the first row of marble slabs of the burial chamber: 1. Five-pointed star; 2. Horse head; 3. Crescent moon on the western side of the entrance (author G. Nekhrizov)*

The plastic decoration is on the orthostatic first course of marble slabs of the burial chamber. Geometric images in relief are represented on 8 of the 14 slabs: disc, squares, rectangles, five-pointed star as well as two realistic images of a horse head and fish (fig. 6.1–2). Plastic squares are made on two of the roof blocks as well. Outside, a crescent moon is cut on the top part of the western pillar of the door frame (fig. 6.3). It is very important to emphasise that the images cut on the marble slabs were coated with mortar plaster and were not visible during the second period of the tomb use. It seems unlikely,
